LOT 27 | 21-31 POINCIANA STREET, HOLLOWAYS BEACH QLD 4878

# SELLER DISCLOSURE & BODY CORPORATE REPORTS

## 6. SUMMARY OF FINDINGS AND RECOMMENDATIONS

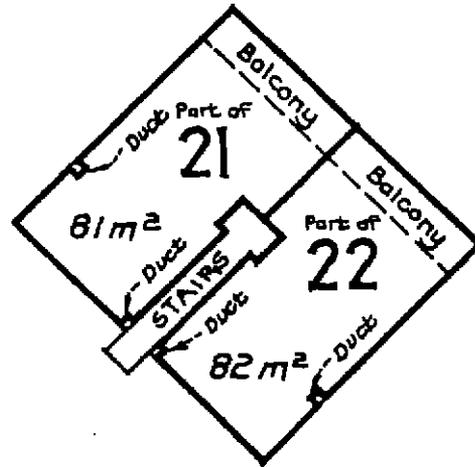
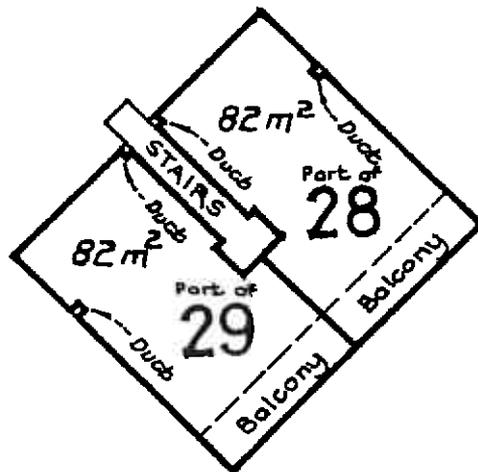
BUILDING UNITS PLAN NO: 363

is hereby stipulated that the uncovered  
parts of Units 21, 23, 28 and 29 extend only  
a height of 2.46 metres.

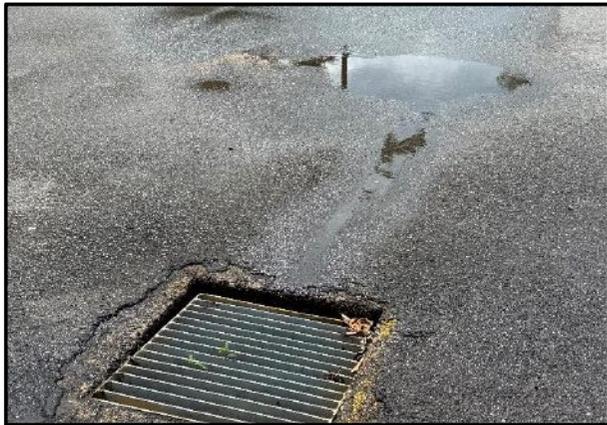
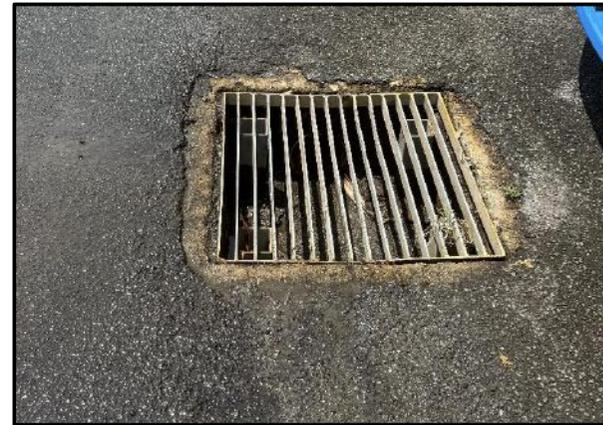
Image 1. Drain grate.

The drain grills have a noticeable dip and faded safety markings.

Drain grills can alter surface levels creating potential trip and fall hazards especially in wet or low conditions.

We recommend applying high-visibility paint markings around the drain grill in the carpark spaces.

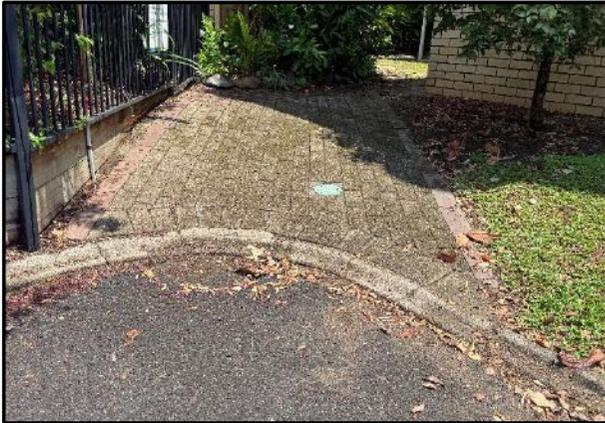
Image 1. Elevated surface.

Image 1: Raised concrete surface.

### Recommendation:

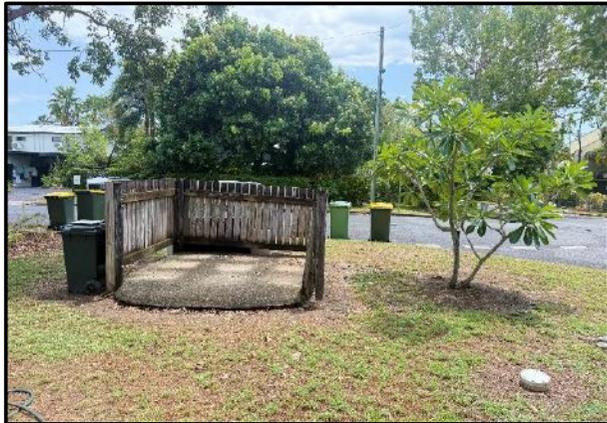
**Image 3.** Wheelie bin storage area.

Image 3: Raised concrete surface to the wheelie bin area.

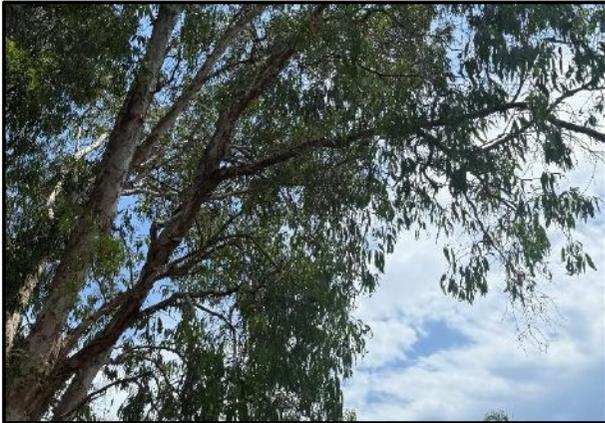
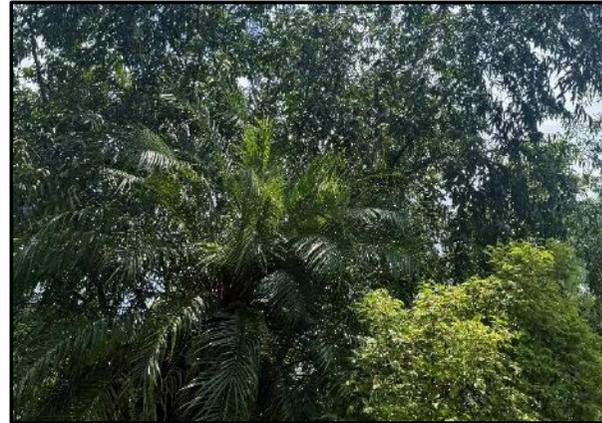
Image 1. Tall trees

Images 1 and 2 are of the same area safety concern. These trees around the property appeared in sound condition without any broken or damaged branches.

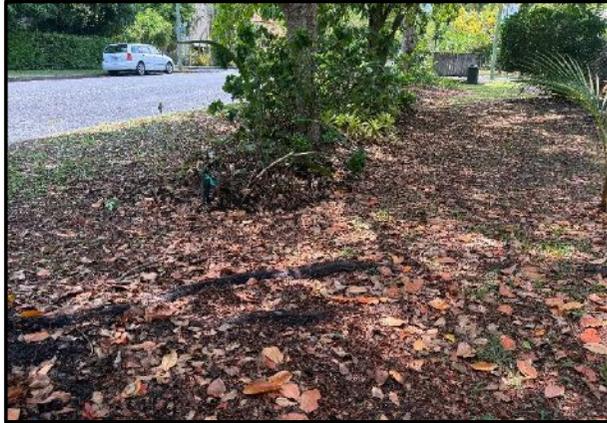
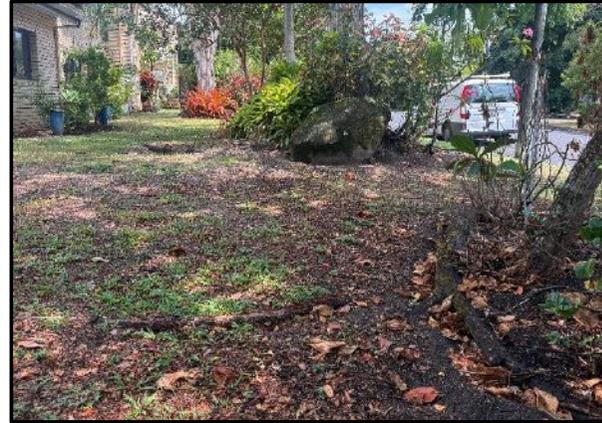
**Image 3.** Debris & tree roots.

Images 3 and 4 are of the same safety concern where there is build-up of debris. Under sections of debris are raised tree roots.

We recommend regularly clearing debris from the area and addressing or removing exposed tree roots to eliminate potential tripping hazards and ensure safe access.

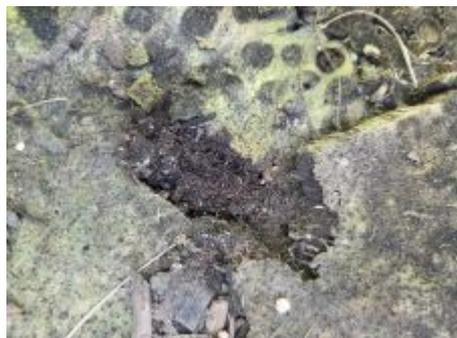
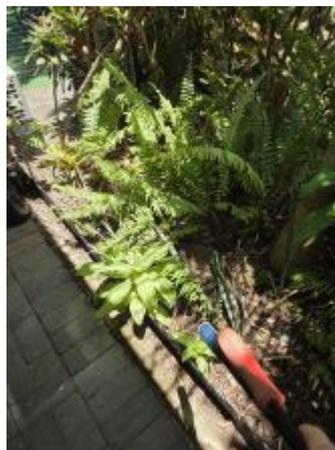
Were live termites found?	Yes
Was a termite nest found?	No
Have any specimens been collected for the purpose of positive identification?	No
The genus or species has been positively identified as:	Microcerotermes (marginally economically important species)
Site Details:	STUMPS Microcerotermes to stump in unit 24 garden.

Microcerotermes

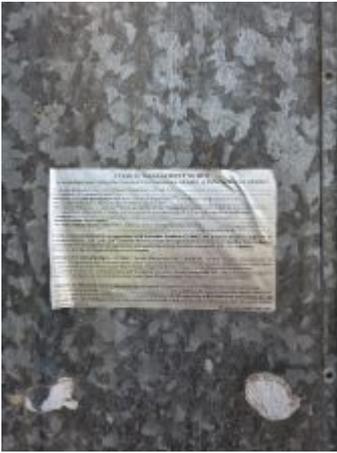
Was evidence of a possible previous termite management program noted?	Evidence of previous chemical treatment Treatment details unclear.
---	---

Evidence of Treatment

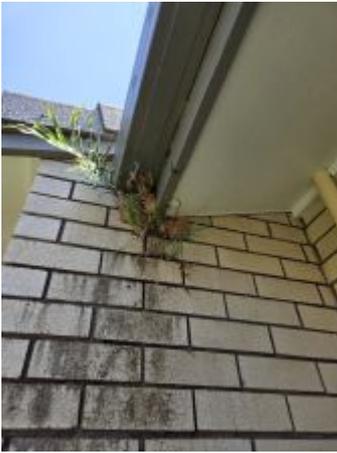
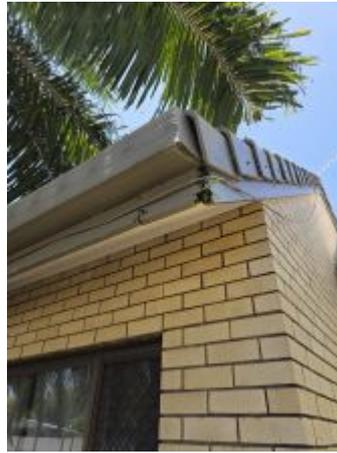
Was evidence of Fungal Decay found?	Yes - see clauses A.4 and A.5
The condition of the timber appears?	Decayed and Decaying
The extent of any visible damage to structures appears:	Moderate
Exterior Details:	<p>FASCIA BOARDS</p> <p>Unit 21, 19, 20, 23, 32 - Minor damage to multiple fascias.</p> <p>TRELLISES</p> <p>Damage to trellises around site.</p>
Site Details:	<p>FENCES</p> <p>Fungal decay to fences around site.</p>
Recommendations:	Areas of Fungal Decay should be repaired/rectified

Fungsl decay examples
